July, 2015 Revised

The Consequence of Not Greasing

Applies to:

All Models – all serial numbers

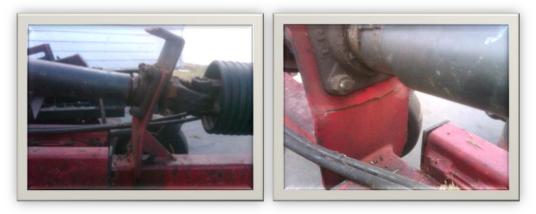
Repeated operation with a seized or binding input shaft slip joint will eventually lead to failure of the hanger bearing bracket as shown below. While this is not a guarantee of protection, this Progressive feature may save the owner from a more expensive PTO drive repair!

Note: Hose guard removed for visual purposes only. Always have guards and shields properly installed when operating

If a failure of this type occurs, Progressive recommends to either replace the bracket with a new part or straighten the bracket and weld the crack. Progressive <u>does not recommend reinforcing the bracket</u>. If the failure is beyond repair, the hanger bearing bracket must be replaced. Always check the hanger bearing for serviceability and replace the input PTO as a complete shaft. Check alignment of the shafts and fully grease the mower before returning it to service.

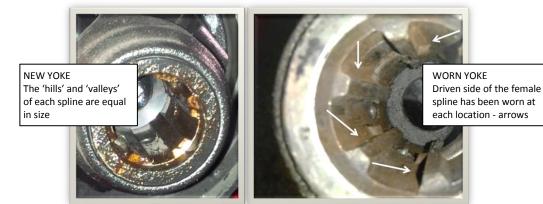
At regular intervals (see Operator's Manual) the PTO shaft must be disconnected from the tractor and the PTO drive stub and yoke cleaned, inspected for wear and lubricated, before reinstallation. A good time to do this is whenever the sliding joint of the PTO shaft is lubricated. Failure to do this may result in the female spines of the yoke wearing as shown in the right hand picture below. As the replacement of the yoke is much less costly than a repair of the tractor's PTO drive stub, by design the PTO shaft yoke is purposely softer than the hardened tractor's PTO drive stub and will therefore become the sacrificial part if wear should occur.

For these same reasons, it is also a good idea to periodically remove, clean and grease all PTO shaft connections to each gear box when performing scheduled service on the PTO shaft.
