## PRO-MAX 36 – PTO UPDATE

The Pro-Max 36 Rotary Finishing Mower has been sold for the past 2 years and there has been a number of machines that experienced failures of the Intermediate Driveshaft. Progressive Turf has decided to provide an update for all of the PM36 mowers affected to date. This will include all serial numbers from 0136002 to 0236026.

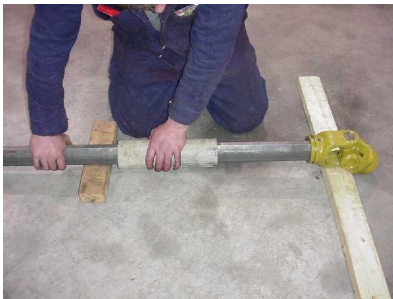
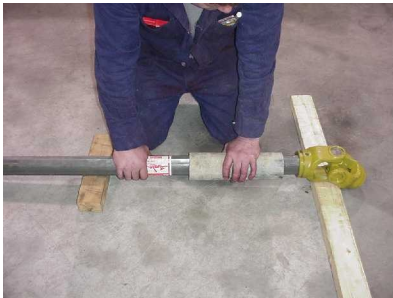
Photo 1

4. Remove the clips from the yellow shield and slide off.
5. The yoke set can now be removed from the tube. Drive the roll pin out first.
6. Slide the Drive Tube, included in the kit, over the shaft and set the shaft on the floor with a small wood 2 x 4 under the one end. See photo 1.

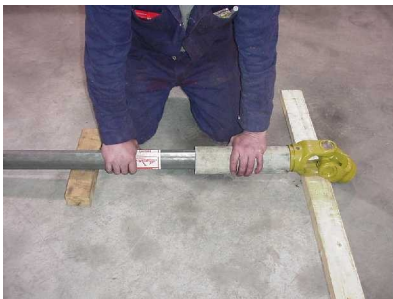
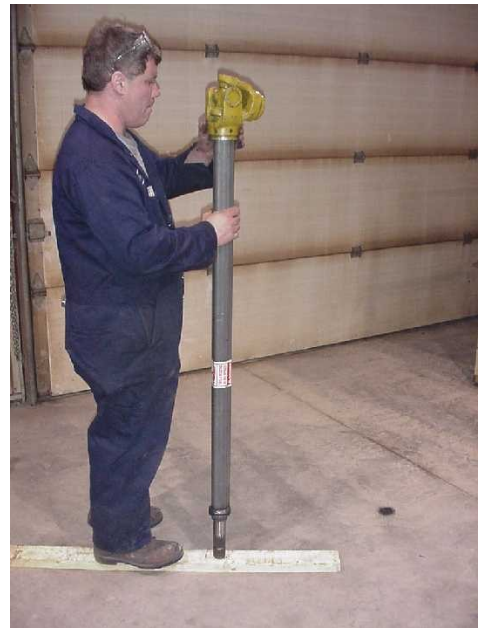
Photo 2

7. With quick and hard sliding motion, drive the yoke set off the tube.
8. Take the new tube provided and start the yoke set on the end.
9. With the yoke started stand the assembly up on the piece of wood and pound it on as shown in photo 2. Watch for and align the roll pin hole in the yoke and tube.

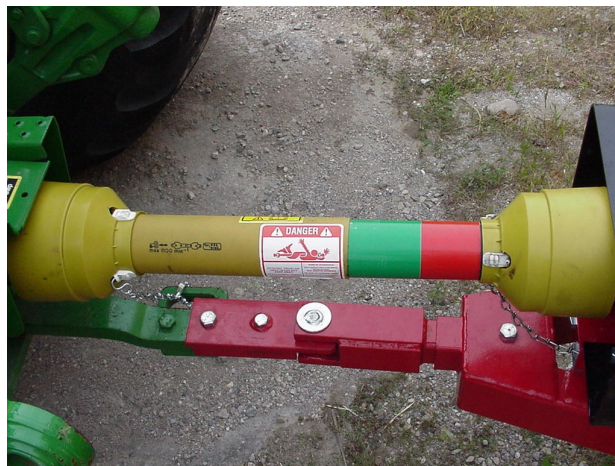
1. There are 2 decals included in the kit. One is to be mounted on the Hose Support (item 1) shown as (item 8) and the other should be mounted on the tractor in normal viewing range of the operator.
2. After mounting the decals review the turning procedure with the operator. They must understand that when turning in the field, while operating the mower, the yellow portion of the shield on the input shaft **MUST REMAIN IN THE GREEN**. Operating in the **RED** will **INTRODUCE HIGH VIBRATIONS** to the shaft and **DANGEROUSLY CLOSE TO BOTTOMING OUT**. (see “Check PTO Length During Transportation”, page 17 of manual)
